# **2017 PROPERTY CONDITION ASSESSMENT REPORT – Volume I – Terminal Site - FINAL**

## **Buffalo Outer Harbor Access and Activation Civic Improvement Project**

901 Fuhrmann Blvd, Buffalo, NY 14203

**August, 2017**

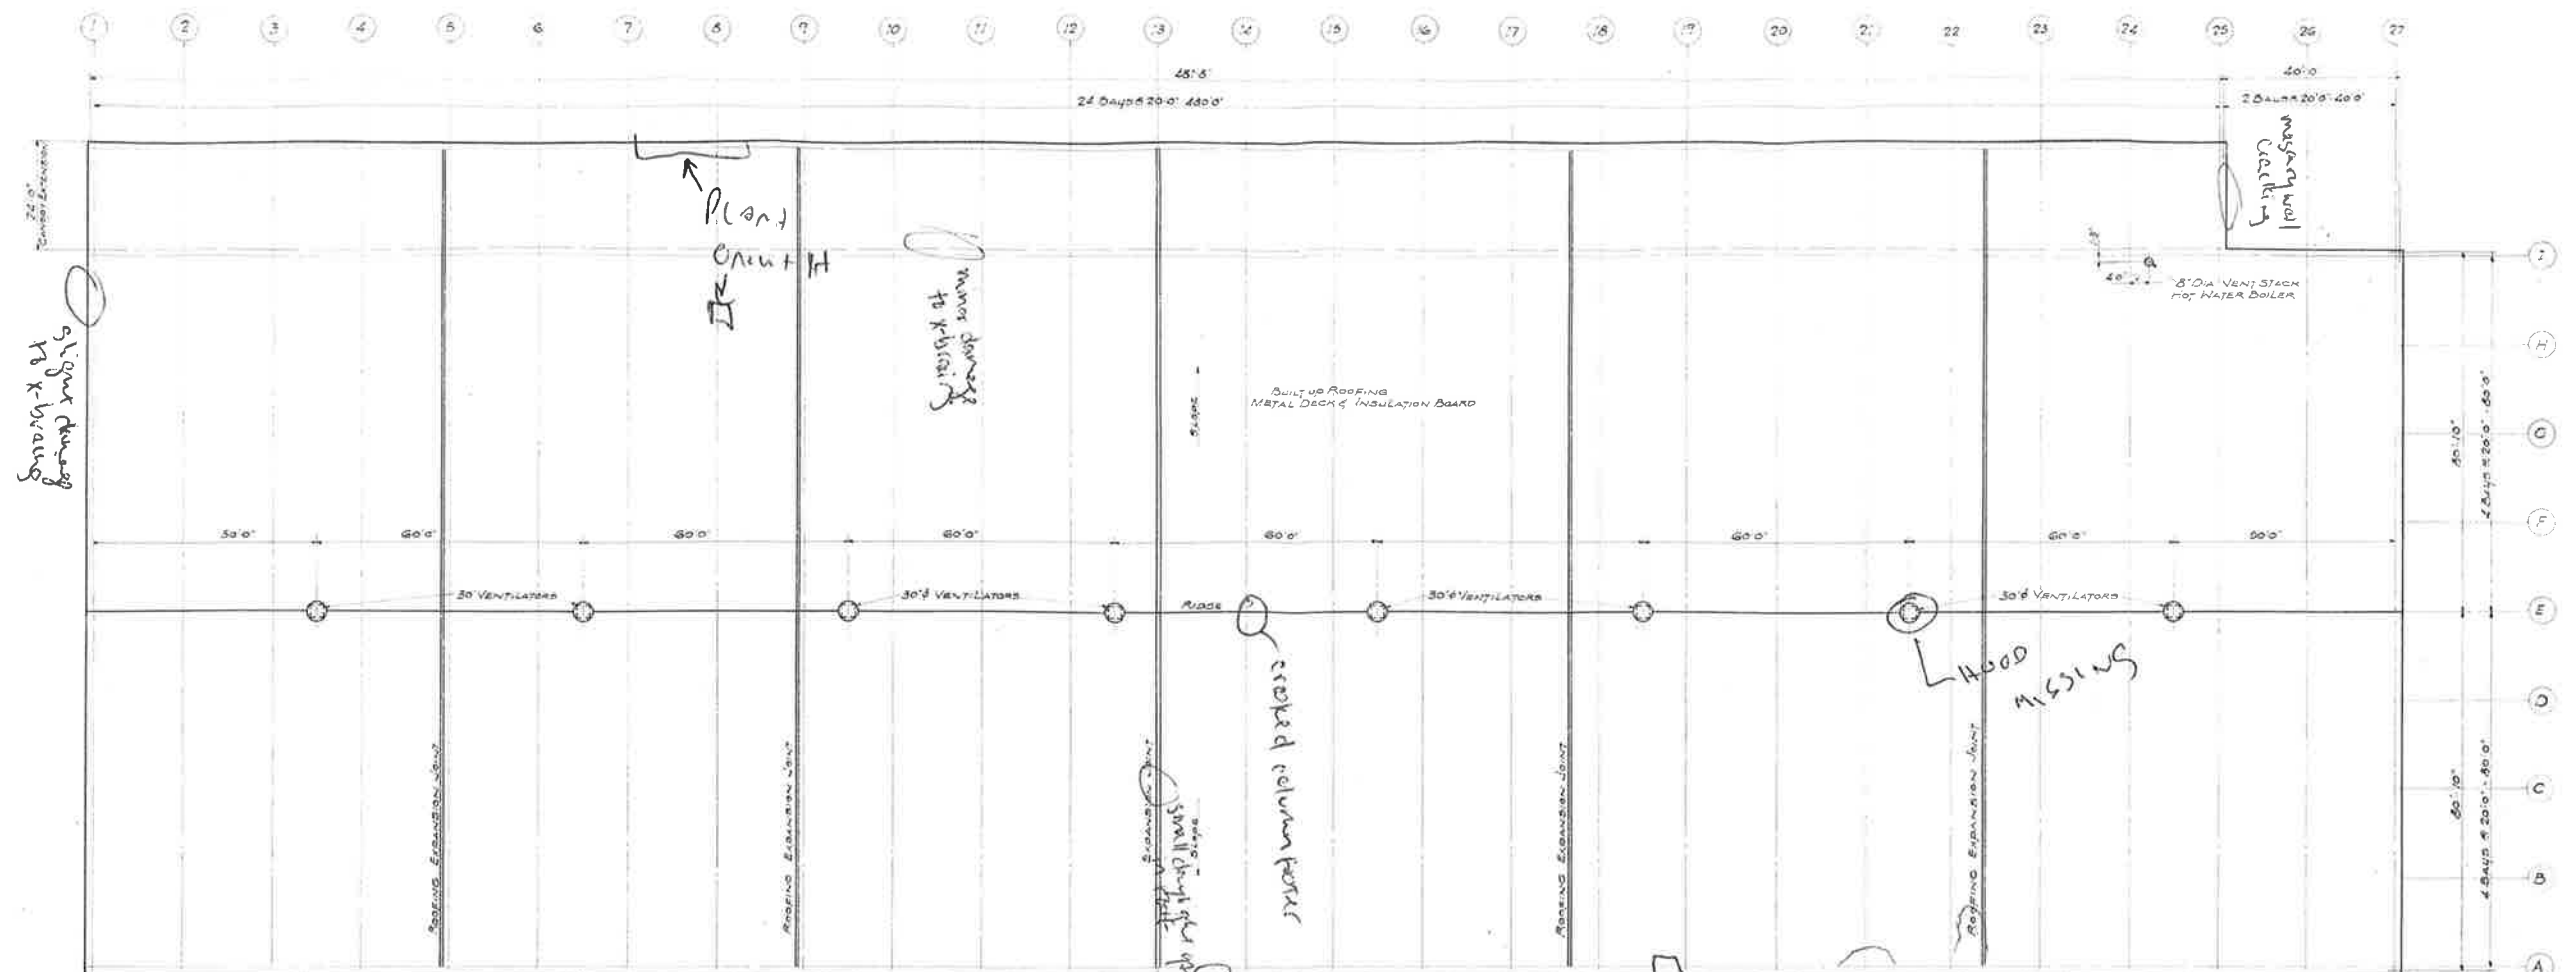
ROOF PLAN

bay 9, water side - minor water damage  
main

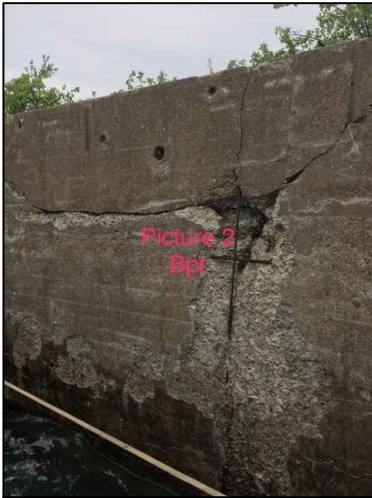
<b>Allen Marine Services</b> UNDERWATER SPECIALISTS			
	CHECKED BY	JB	6-29-17				
LOCATION Buffalo, NY	GENERAL NOTES: West Wall			SCALE	JOB NO.	DWG NO.	REV
TITLE Inspection Results - Bollard #2 to Bollard #4				NTS	72130-001	W2	1

NOTE:  
- THERE IS A 4x4 ANGLE IRON RUNNING THE LENGTH OF THE WALL ON THE BOTTOM CAP. MOST OF THIS ANGLE IRON IS MISSING. WHAT IS LEFT IS NOT IN GOOD CONDITION.

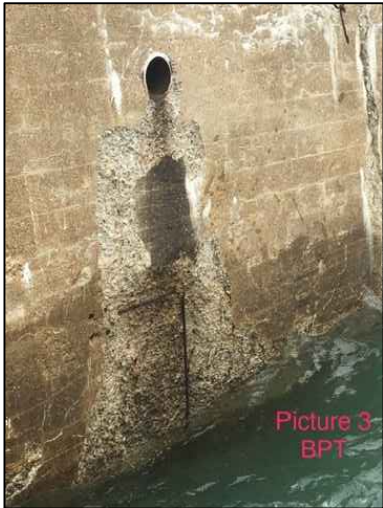
<b>Allen Marine Services</b> UNDERWATER SPECIALISTS</div>			
	CHECKED BY	JB	6-29-17				
LOCATION Buffalo, NY	GENERAL NOTES: West Wall			SCALE	JOB NO.	DWG NO.	REV
TITLE Inspection Results - Bollard #4 to Bollard #6				NTS	72130-001	W3	1

NOTE:  
- IN GENERAL, THERE ARE PILES EVERY 6'.  
- SHEET PILE WALL IN GOOD CONDITION WITH 1" TO 2" OF ZEBRA MUSSELS.
